ACC Acheson 2-26-52-26 Acheson Field December 2004 Blowout

**EUB Investigation Team Post-Incident
Analysis and Recommendations**

July 2005

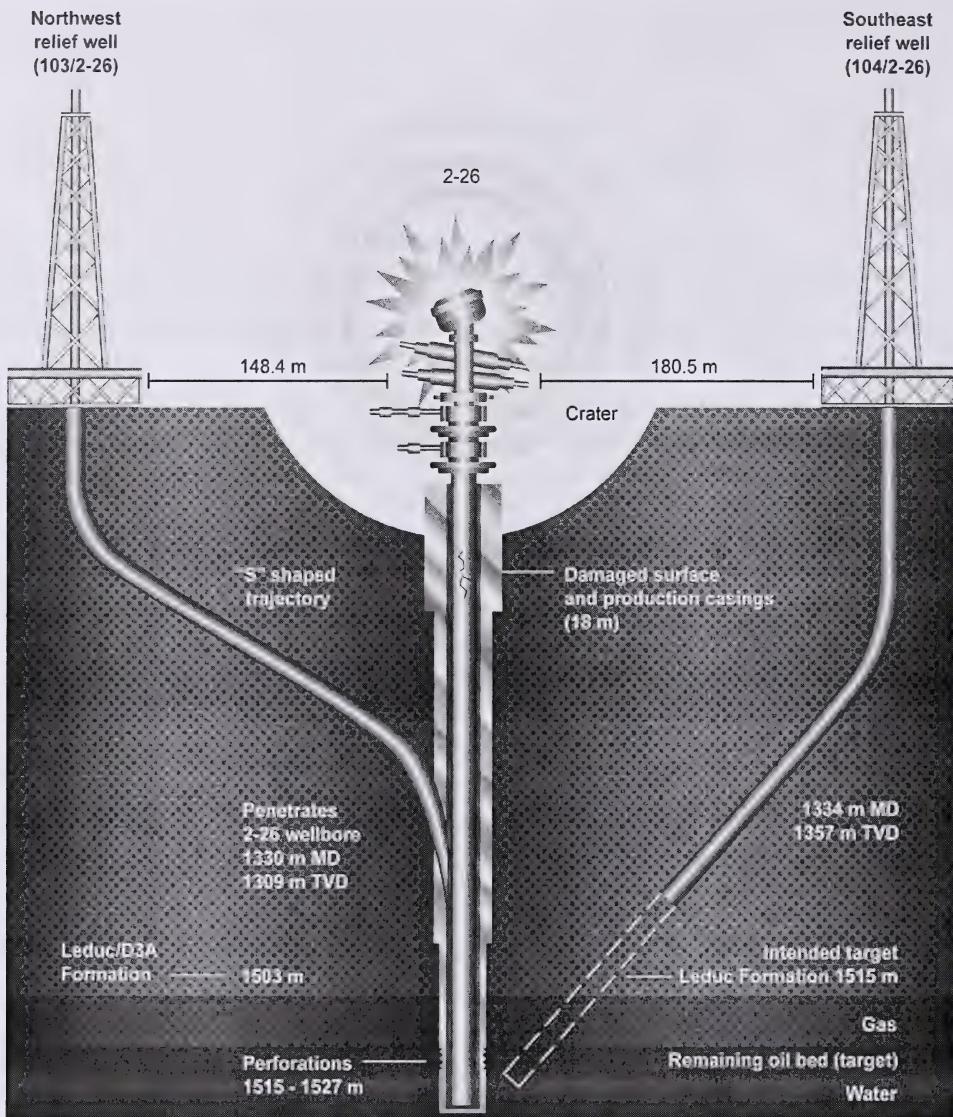
Figure 1. Relief well configurations (adapted from “Diagram of Relief Well Plan” in Appendix 7 of the Acclaim Energy Inc. Acheson 2-26-52-26W4M Well Blowout Report)

On December 15, Acclaim, in consultation with the EUB, decided that the best way to proceed was to reignite the 2-26 well and drill two relief wells (see Figure 1). If the gas was burning, most of the H₂S would be converted to sulphur dioxide (SO₂), providing

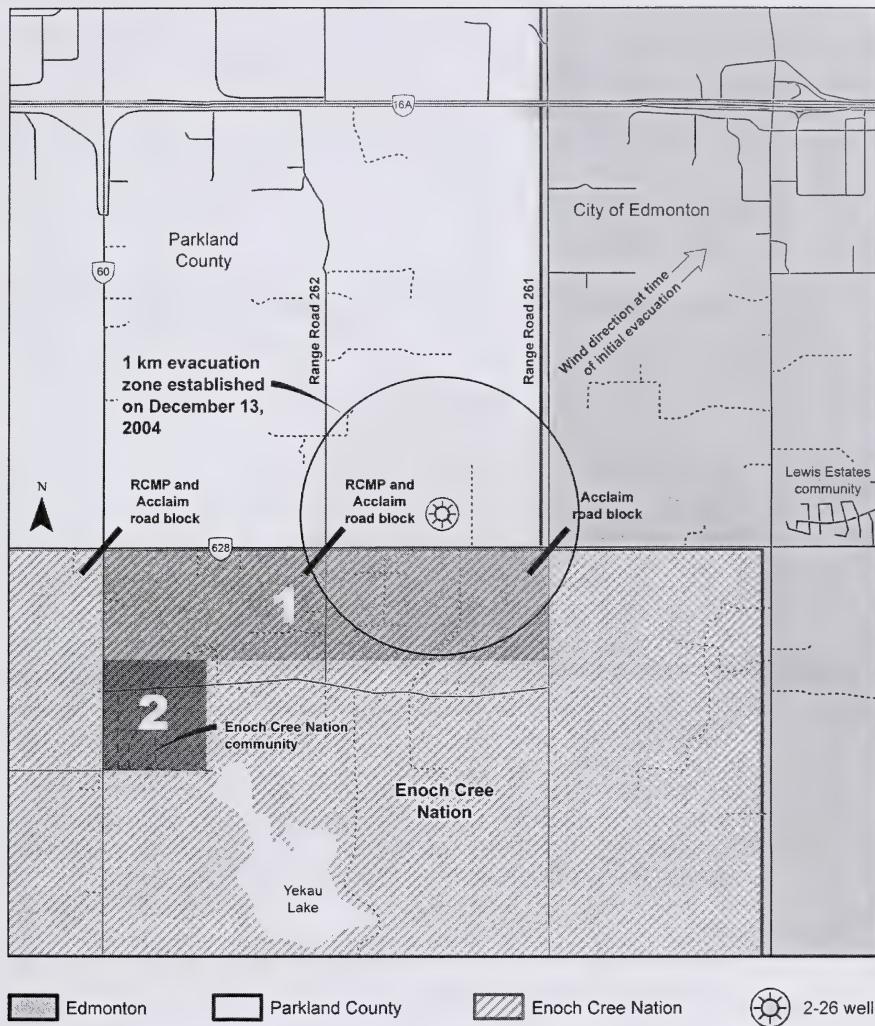
Figure 2. Acclaim blowout: Areas of evacuation

All evacuees were asked to leave the area immediately because of the blowout, but were given very little information:

- They were not given specific travel routes to follow to avoid entering the gas plume from 2-26.
- They were directed to find their own accommodations without reporting to a reception centre for registration.
- They were not given any instructions as to who would take care of their needs and expenses.
- They were not informed as to whom they should contact if problems arose, and they did not know who would look after the security of their property, pets, or livestock while they were evacuated.
- Moreover, the parties conducting the evacuations did not prepare a common message or set of instructions to be delivered to the evacuees.

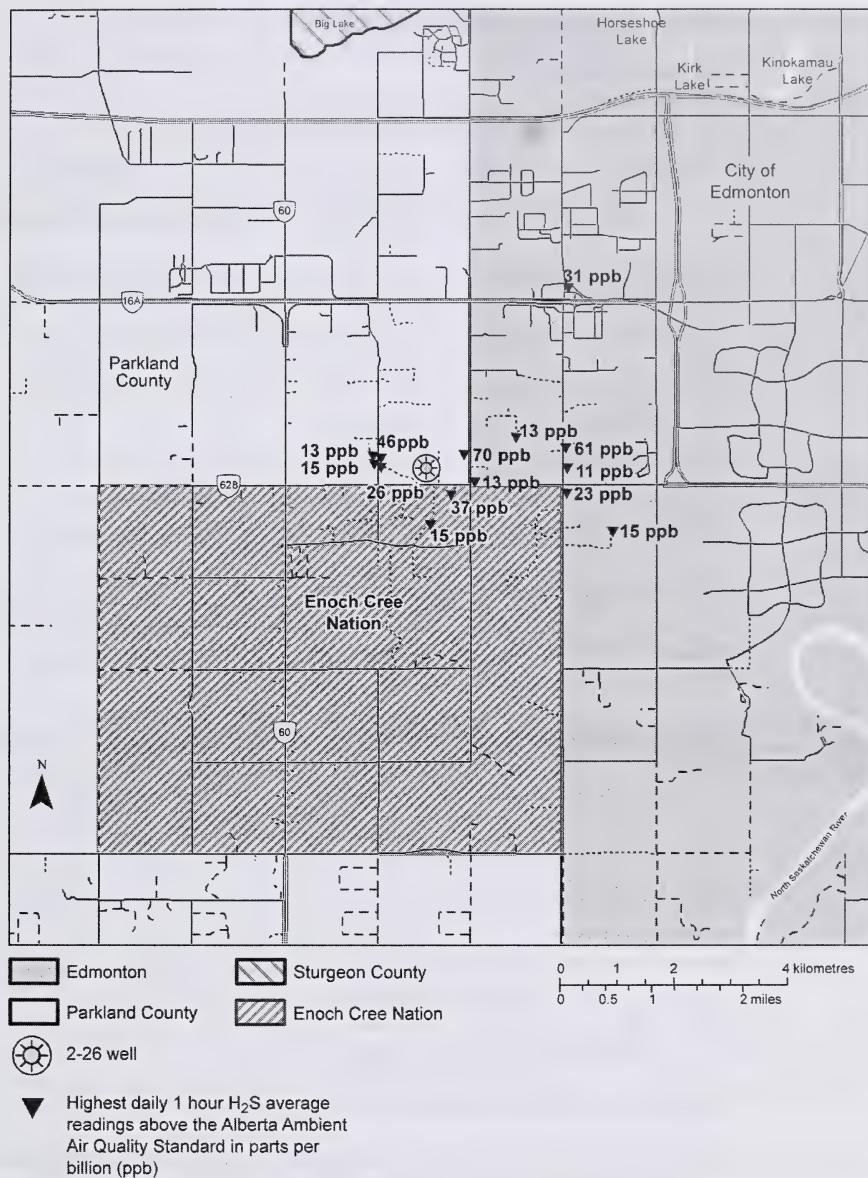
Figure 4. Locations of one-hour H₂S average readings from mobile air monitoring units relative to the 2-26 well

The highest instantaneous peak recorded for H₂S was 496 ppb on December 12. The highest one-hour average recorded for H₂S was 70 ppb on December 15. Both of these recordings occurred approximately 500 m east, downwind of the well site. The one-hour average community exposure Alberta Ambient Air Quality Objective (AAAQO) for H₂S is 10 ppb. This concentration is primarily set for odour annoyance purposes, not evacuation. Of the 3055 hours monitored, there were 63 occurrences in total where the one-hour average exceeded 10 ppb, the highest being the 70 ppb previously noted. These levels occurred in the first few days of the incident and were recorded primarily north and east, downwind of the well site. The levels were lower than the H₂S notification and evacuation requirements in Table 1 below.

The highest one-hour average recorded for SO₂ was 59 ppb on December 14 which is lower than the one-hour community exposure AAAQO for SO₂ of 170 ppb and the SO₂ evacuation requirement in Table 1.

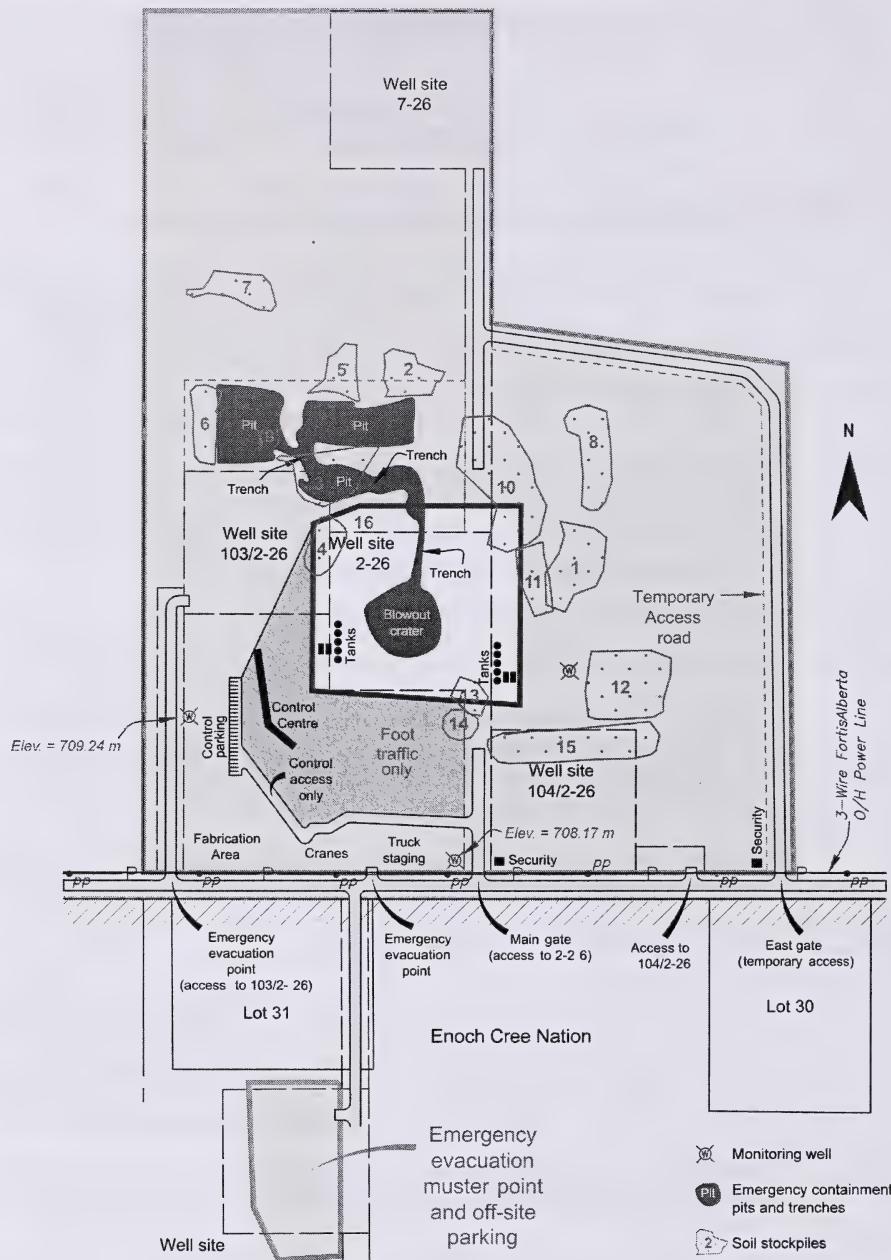
Figure 5. Acclaim blowout: Monitoring wells, soil stockpiles, and emergency containment pits and trenches (adapted from “Area Map Showing Pile Volumes for Acclaim 2-26-52-26W4 within Parkland County,” in Appendix 10 of Acclaim Energy Inc. Acheson 2-26-52-26W4M Well Blowout Report)

Acclaim provided analytical results for the 02-26 site to the EUB for the impacted soils (oilfield waste), the pit walls, and the floor (east, west, and south trenches, well pits, and ramps).

Dewatering wells reduced the water level around the 2-26 well and removed contaminated groundwater. Chloride levels in the dewatering wells were significantly lower than in the produced water. Acclaim plans to conduct an electromagnetic survey to further delineate impacts on groundwater and drill additional monitoring wells if necessary.
